Attention: [REDACTED]
Report 685026-AFC
Project Name GOULBURN HOSPITAL
Project ID SYD191088.P003
Received Date Oct 29, 2019
Date Reported Oct 29, 2019

Project Name GOULBURN HOSPITAL
Project ID SYD191088.P003
Date Sampled Oct 28, 2019
Report 685026-AFC

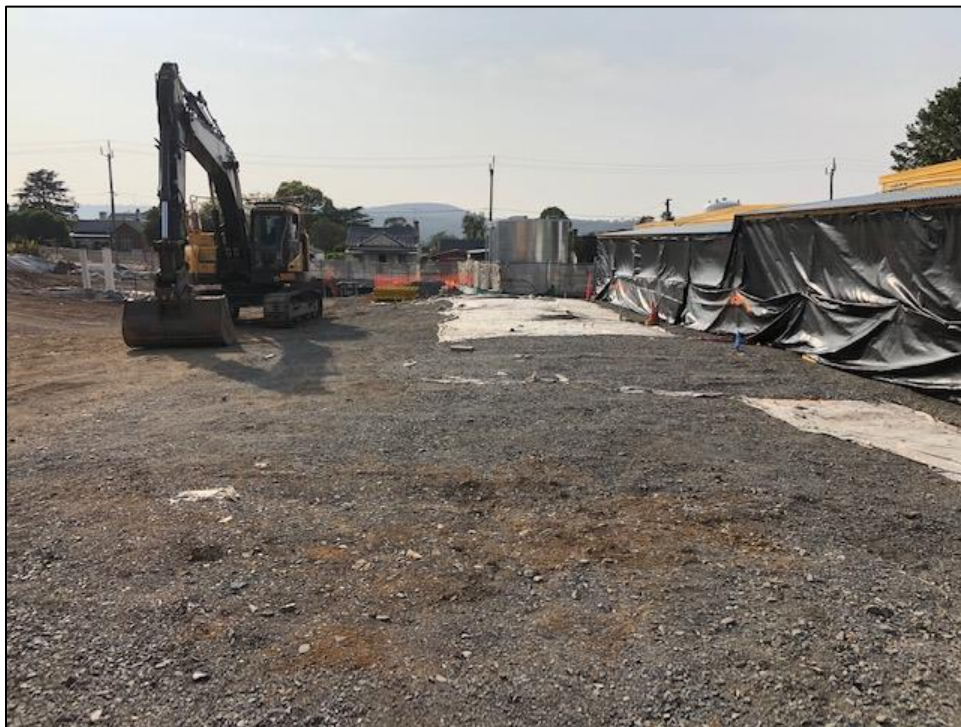
Photograph prior to containment cell excavation. Note black plastic on site office and entry was restricted.

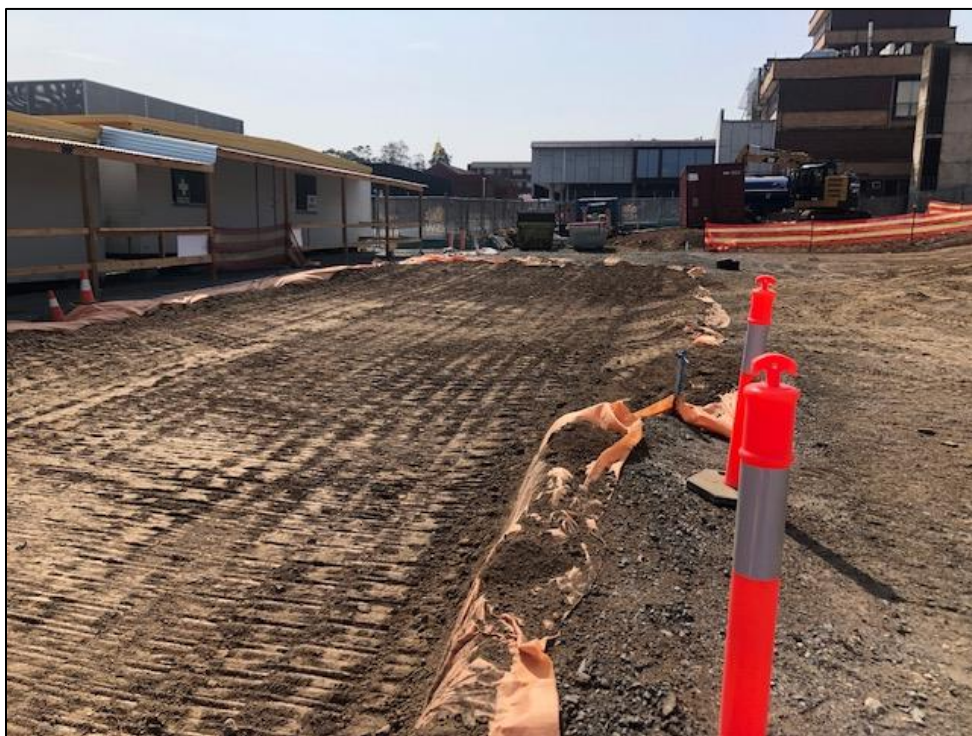
Photograph Post excavation and geotextile barrier evident on pit walls.

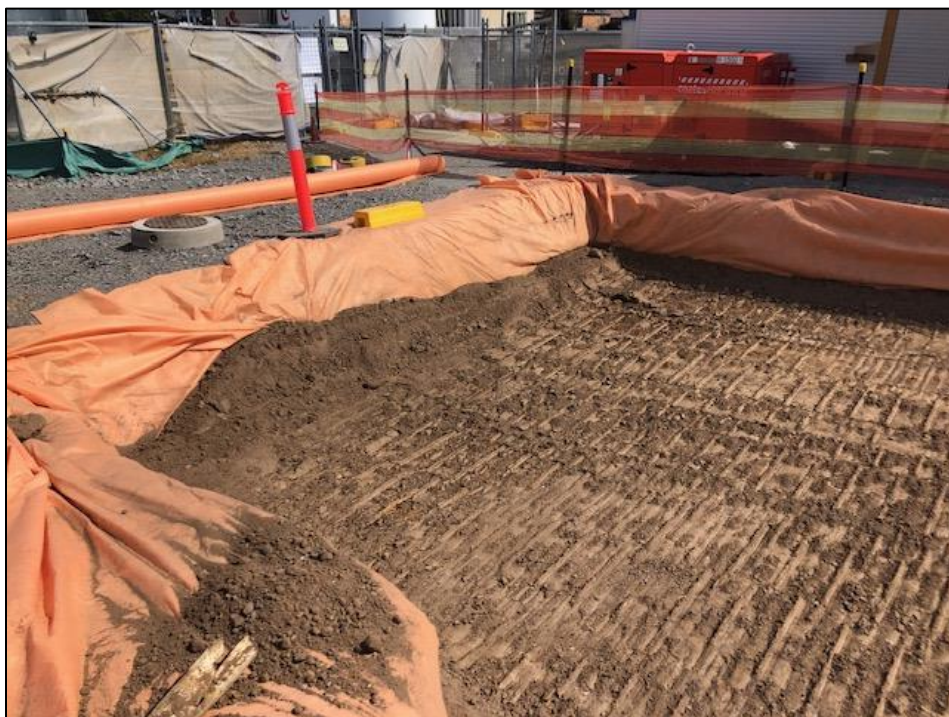
Photograph 1 Post excavation and geotextile liner evident on pit walls. Not varying depth of excavation to accommodate future site works.

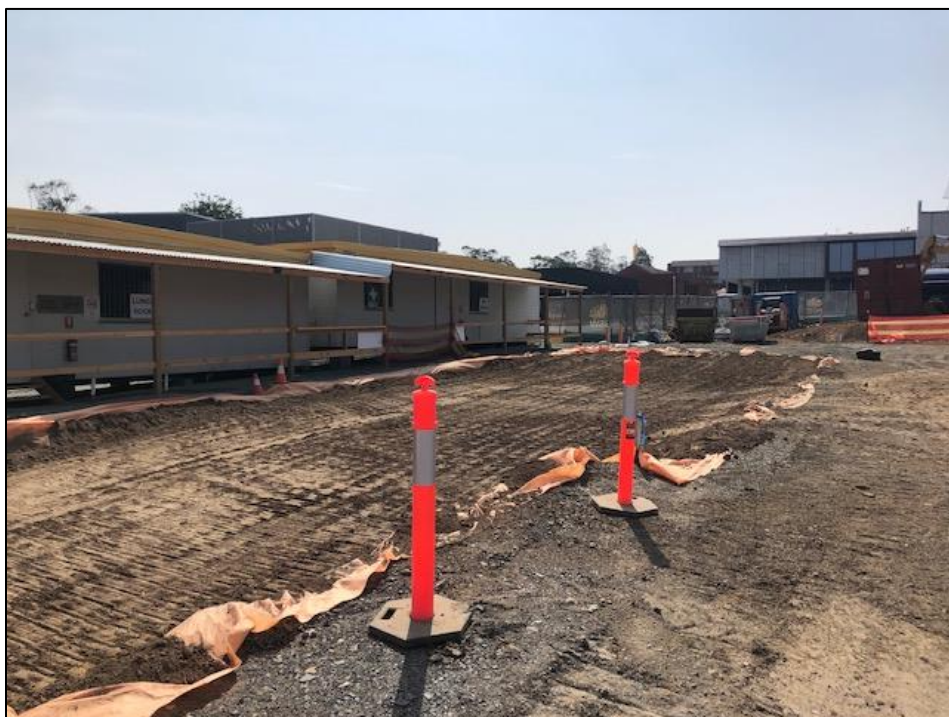
Photograph 2 Post excavation and geotextile liner evident and use of clean fill.

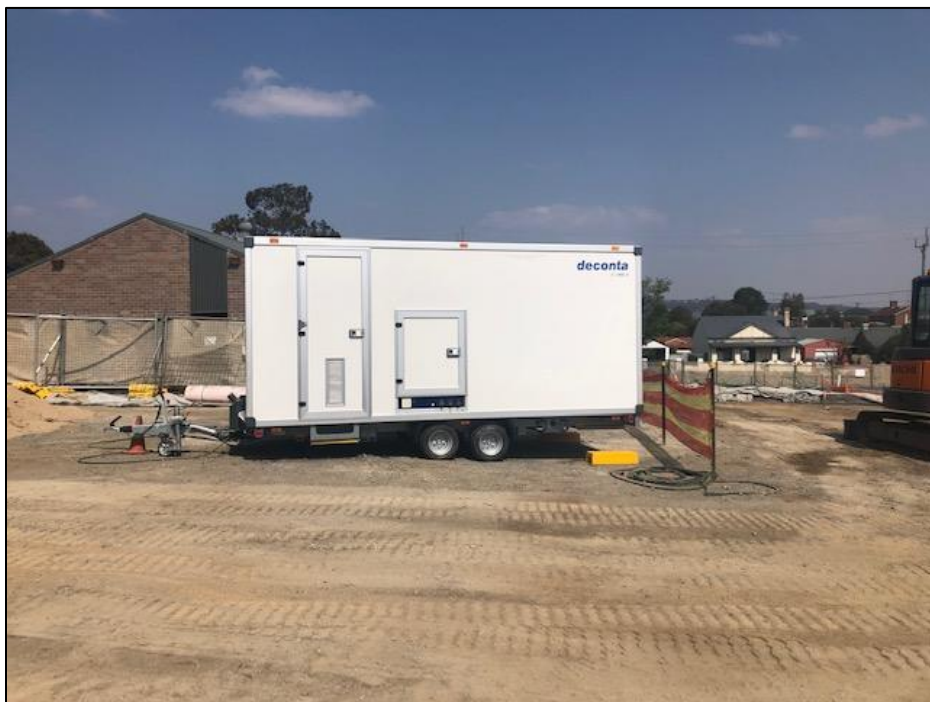
Photograph 1 Deconta ination unit

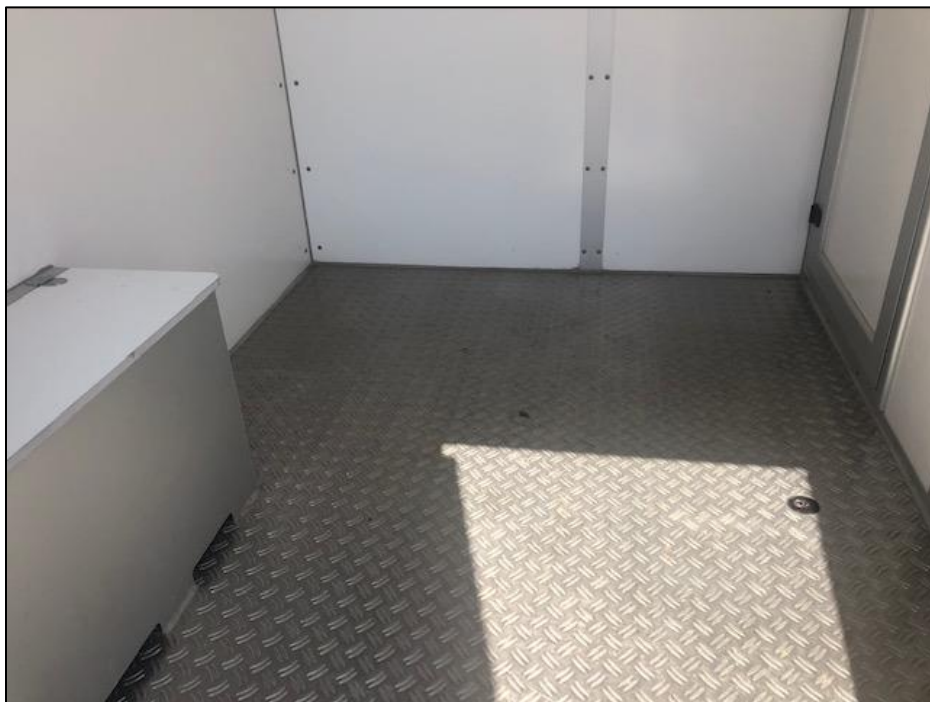
Photograph 2 Interior of Deconta ination unit

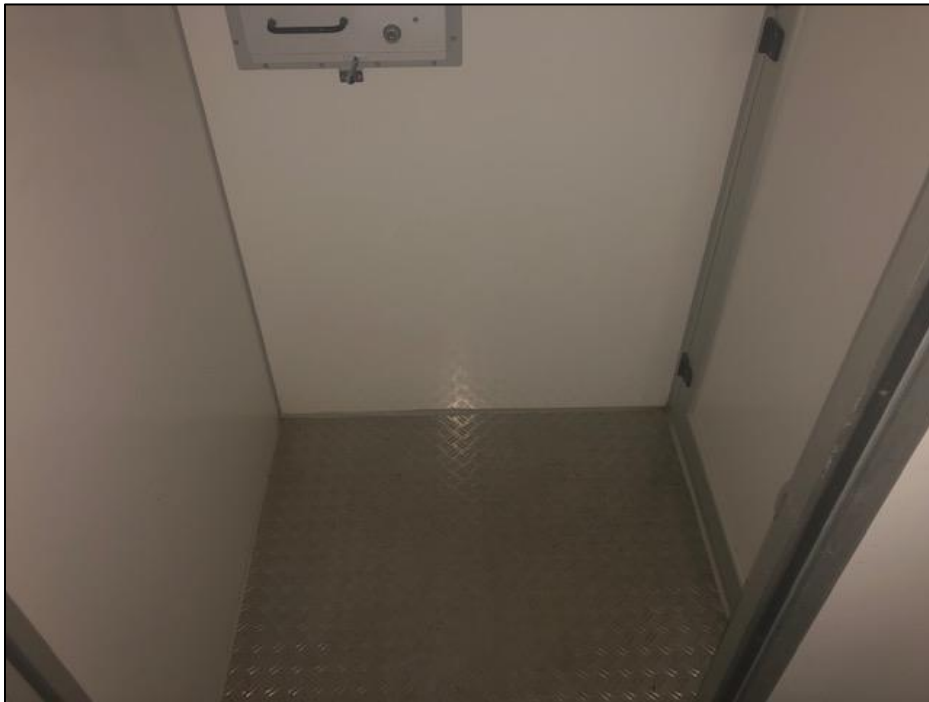
Photograph 1 Interior of Decontamination Unit

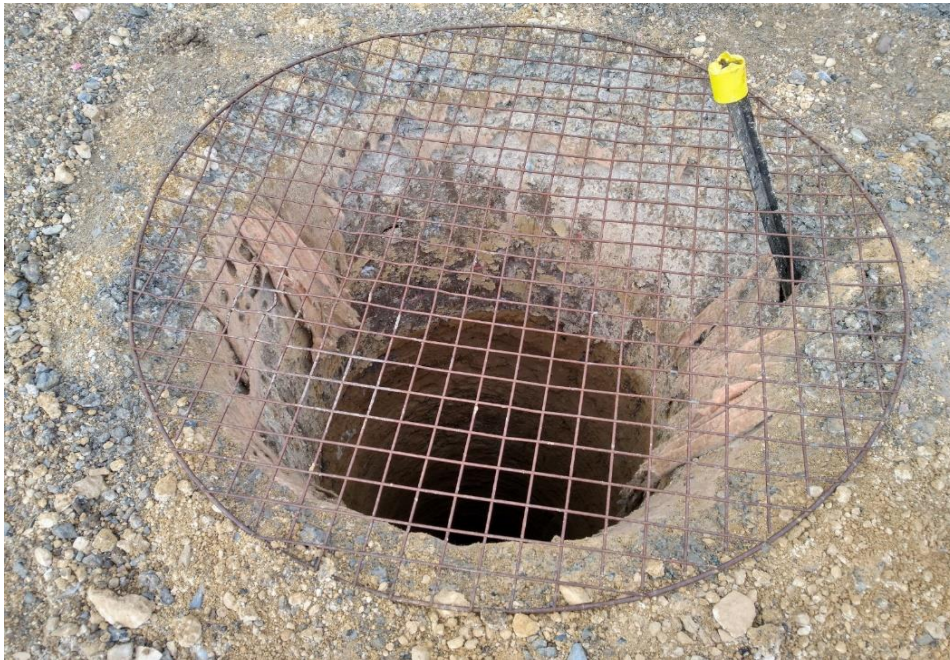
Photograph □□Typical piling hole□
