# Appendix K – Asbestos, Air, Dust & Vibration Monitoring

Project 94054.06  
13 May 2020  
R.010.Rev0  
JS:TK

**Asbestos Clearance Inspection**  
**Proposed Contractor Car Park, Goulburn Hospital**  
**Corner of Fitzroy Street and Mount Street, Goulburn NSW**

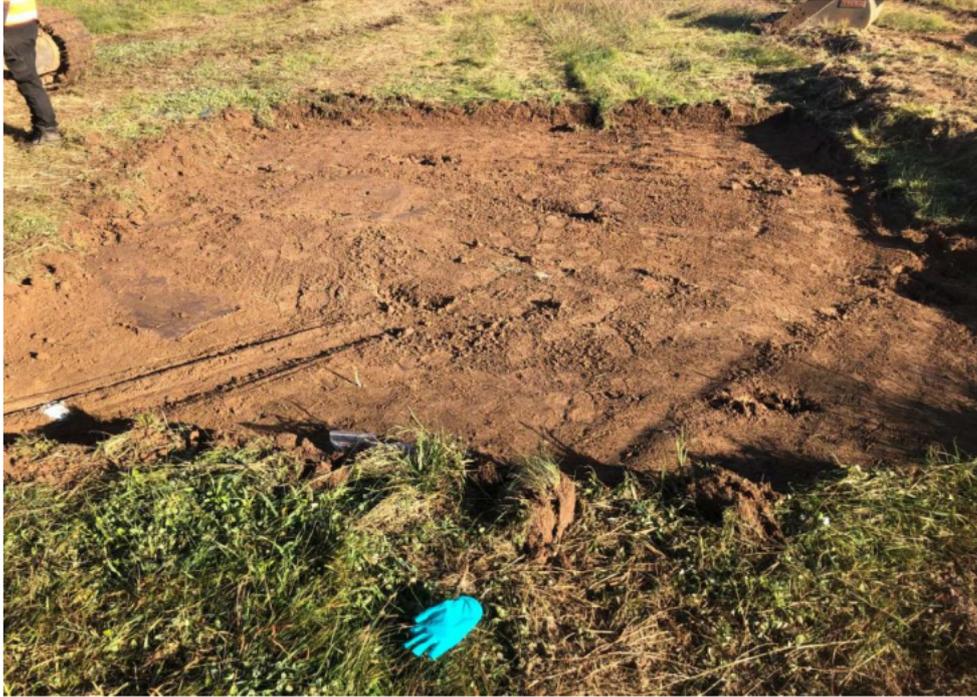
At completion of the visual inspection the assessor found no visible asbestos residue from asbestos removal work in the Area Inspected, or in the vicinity of the Area Inspected where the work was carried out. The vicinity of the Area Inspected comprises the associated truck loading area, decontamination area and transit route.

Photograph 1: Final excavation at Test Pit 8 (looking west).

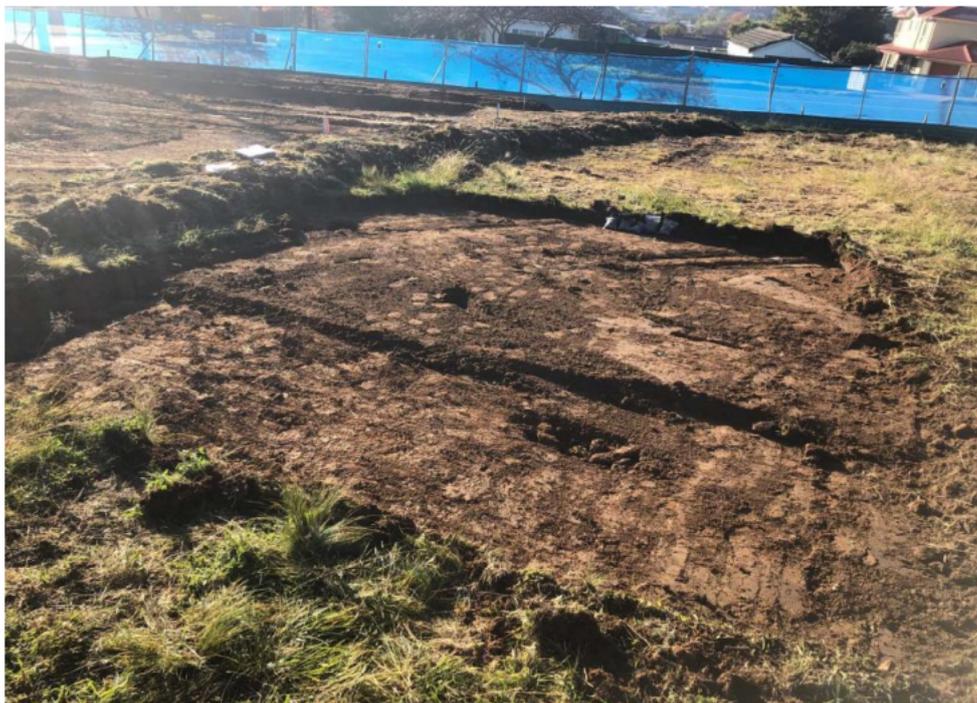
Photograph 2: Final excavation at Test Pit 8 (looking east).
