Appendix K – Asbestos, Air, Dust & Vibration Monitoring

To	[REDACTED]	Hansen Yuncken Pty Ltd	[REDACTED]
From	[REDACTED]		Date 27 May 2020
Subject	Vibration Monitoring Report 19 Goulburn Base Hospital Redevelopment		Project No. 94054.07 Doc. No. 94054.07.R.019.Rev0

To	[REDACTED]	Hansen Yuncken Pty Ltd	[REDACTED]
From	[REDACTED]		Date 03 Jun 2020
Subject	Vibration Monitoring Report 20 Goulburn Base Hospital Redevelopment		Project No. 94054.07 Doc. No. 94054.07.R.020.Rev0

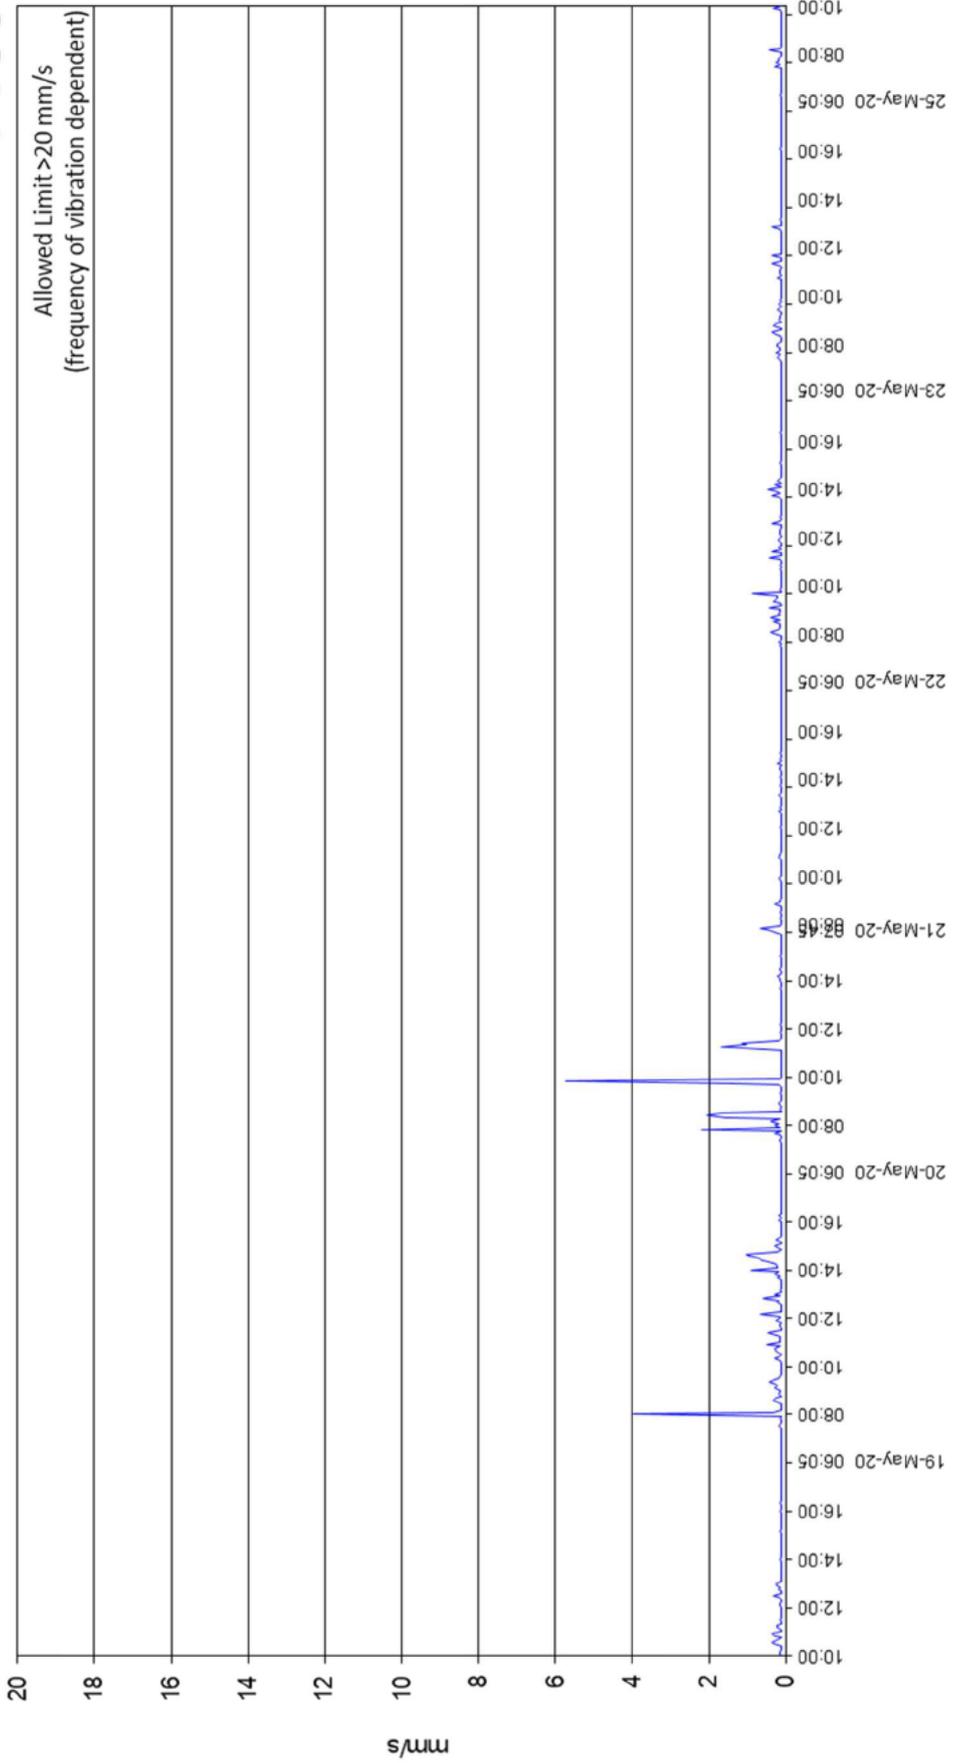
Vibration Levels - Goulburn Base Hospital Redevelopment
 (Monitoring Location B - NE-cnr of pathology-mortuary building)

Location	Monitor	Exceedances		Time of maximum exceedance
		No.	Max (VSPPV)	
Monitoring Location A	7113	2*	27.7	25-May, 8:47 am
Monitoring Location B	7153	0	n/a	n/a

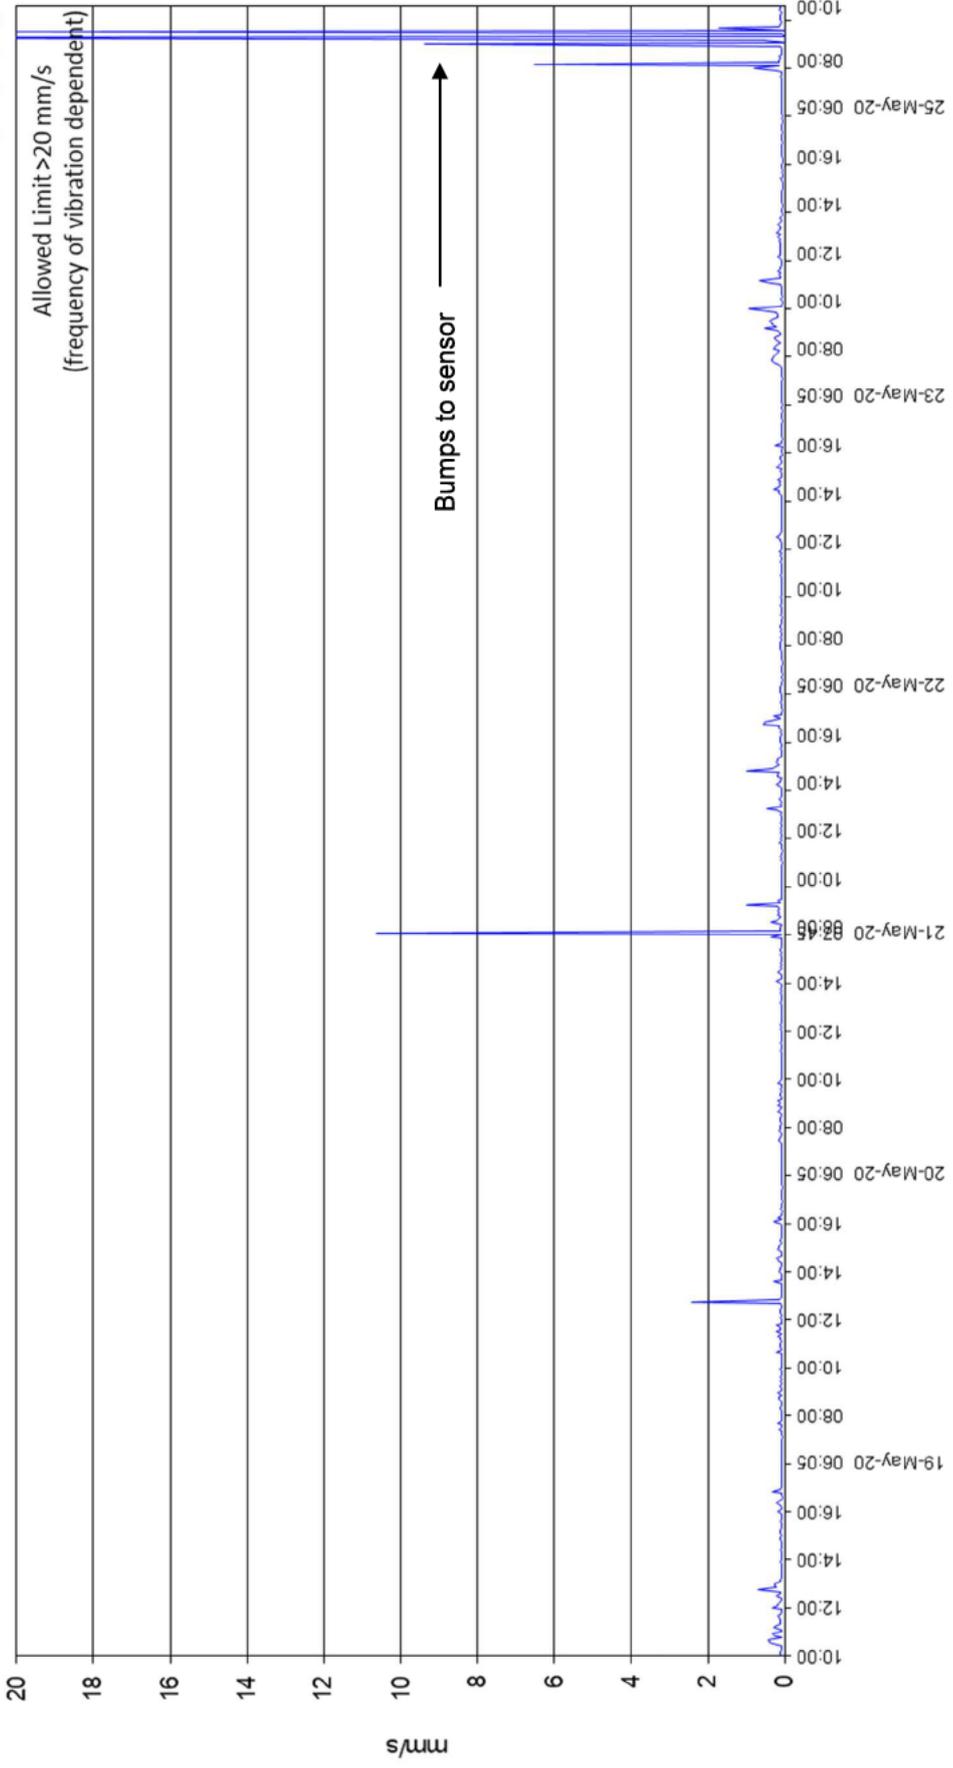
Vibration Levels - Goulburn Base Hospital Redevelopment
(Monitoring Location A - SE-cnr of pathology-mortuary building)

*All exceedances likely direct bumps to sensor. Exceedances were not included in eVDV calculations.
