Appendix K – Asbestos, Air, Dust & Vibration Monitoring

To	[REDACTED]	Hansen Yuncken Pty Ltd	[REDACTED]
From	[REDACTED]		Date 27 May 2020
Subject	Vibration Monitoring Report 19 Goulburn Base Hospital Redevelopment		Project No. 94054.07 Doc. No. 94054.07.R.019.Rev0

To	[REDACTED]	Hansen Yuncken Pty Ltd	[REDACTED]
From	[REDACTED]		Date 03 Jun 2020
Subject	Vibration Monitoring Report 20 Goulburn Base Hospital Redevelopment		Project No. 94054.07 Doc. No. 94054.07.R.020.Rev0

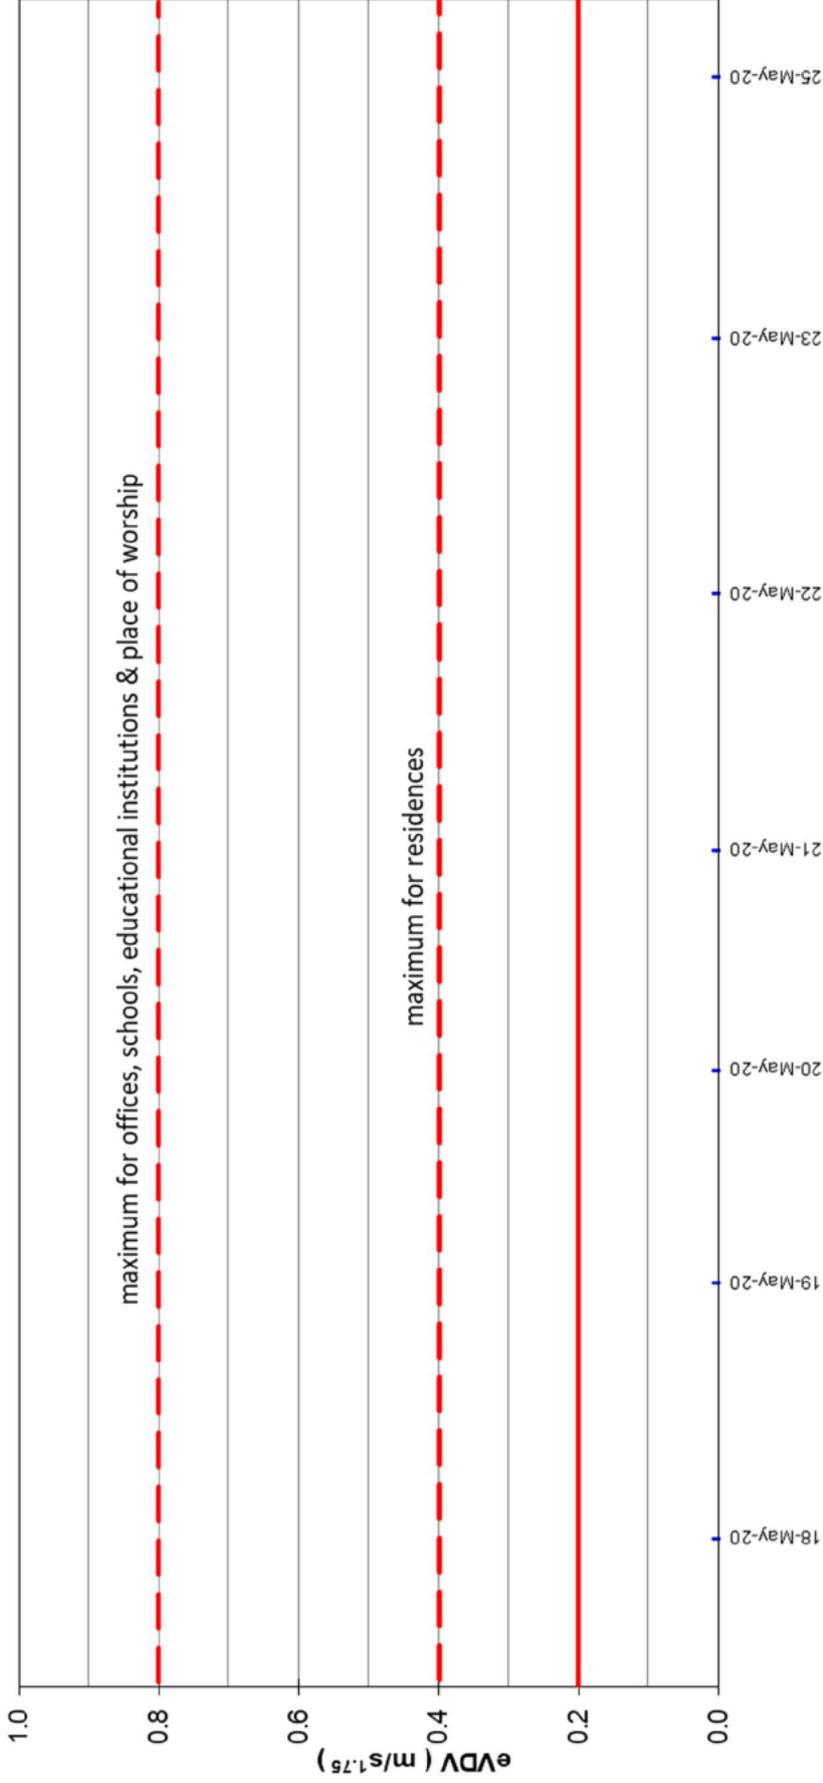
Monitor
7153

— Estimated Vibration Dose Value (maximum component) - - - Allowed Vibration Dose (maximum for critical areas)

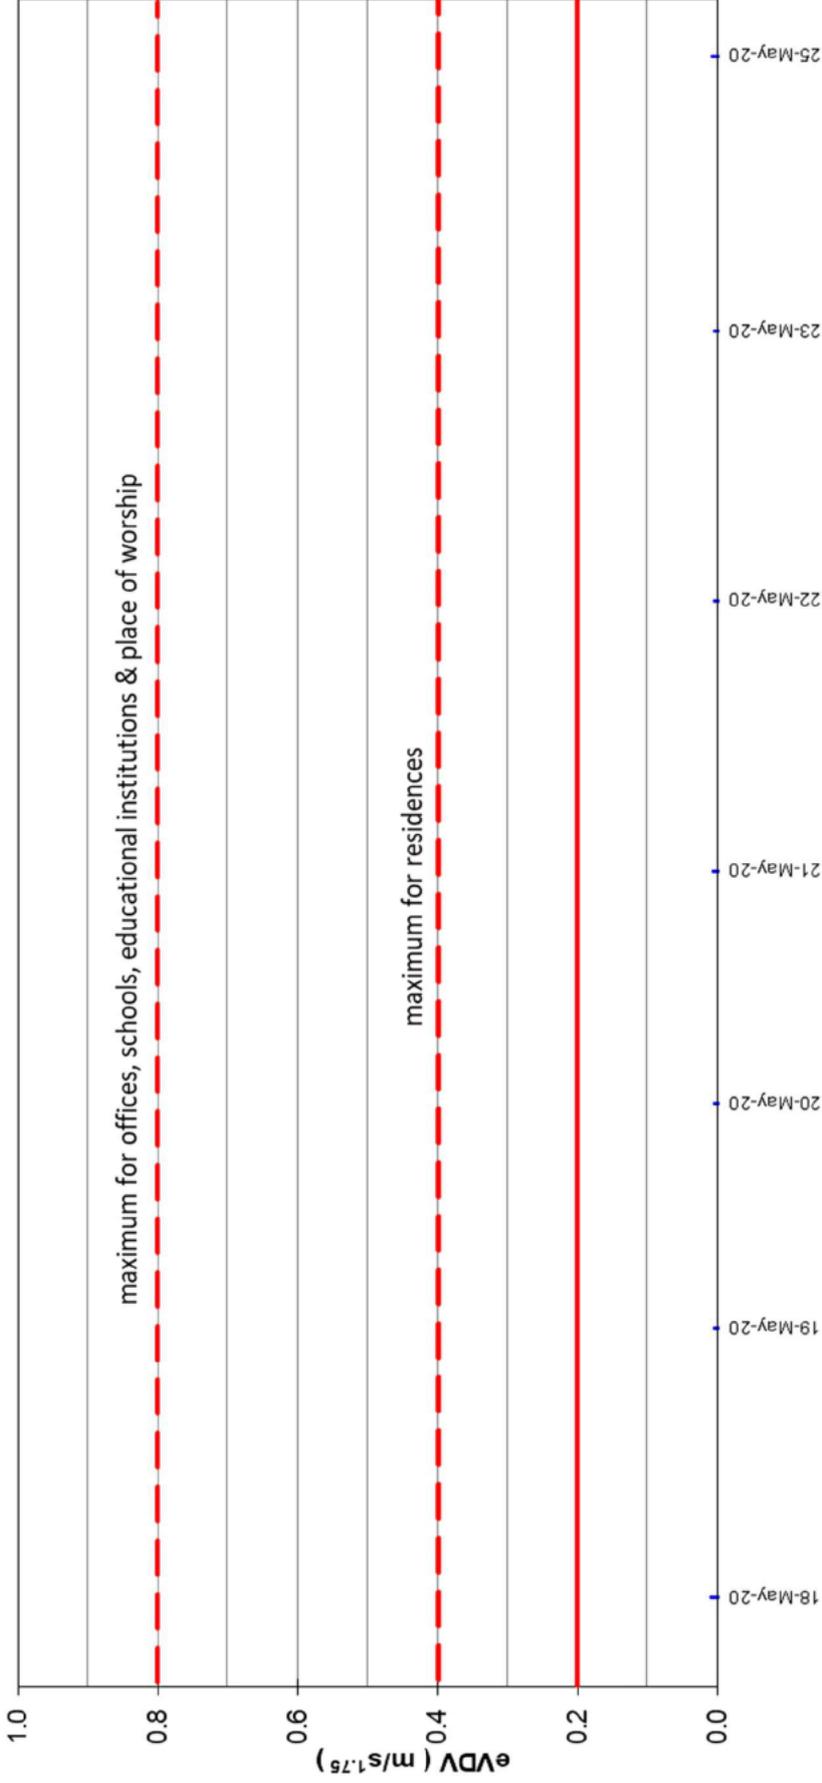
**Monitor
7113**

Location	Monitor	Exceedances		Time of maximum exceedance
		No.	Max (VSPPV)	
Monitoring Location A	7113	2*	27.7	25-May, 8:47 am
Monitoring Location B	7153	0	n/a	n/a

— Estimated Vibration Dose Value (maximum component) — Allowed Vibration Dose (maximum for critical areas)

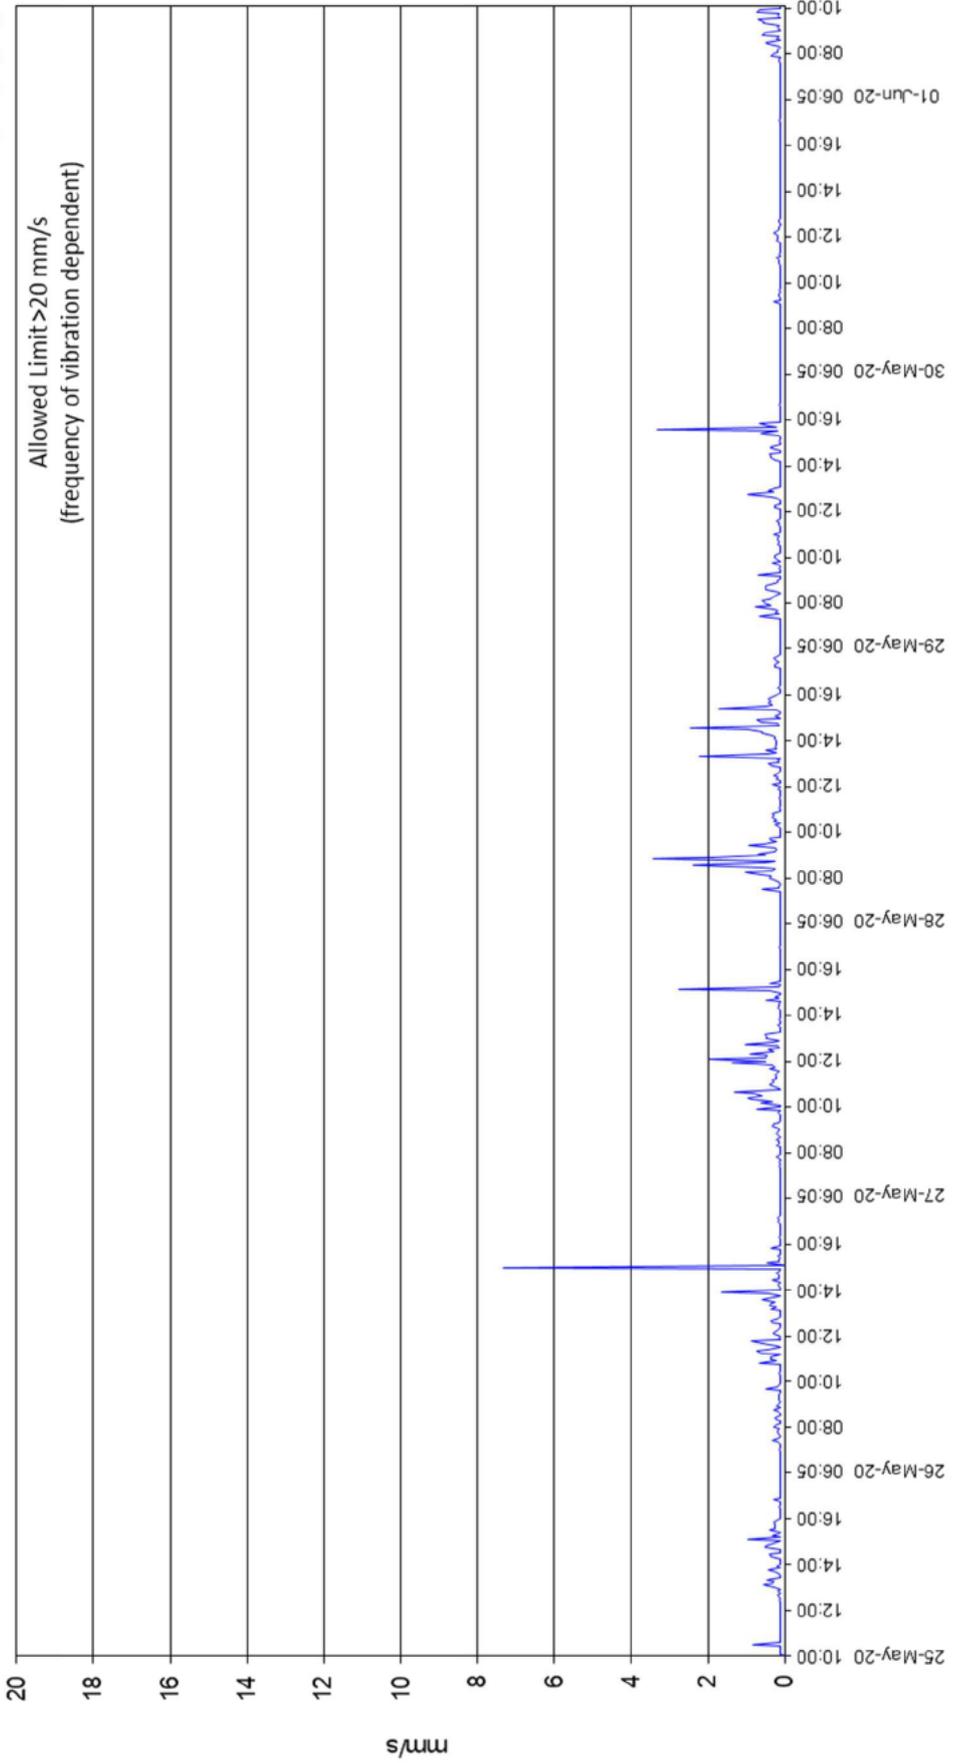
Monitor
7153

— Vector Sum Peak Particle Velocity (maxima within 5 min contiguous windows) & triggered events > 7 mm/s — Allowed Limit

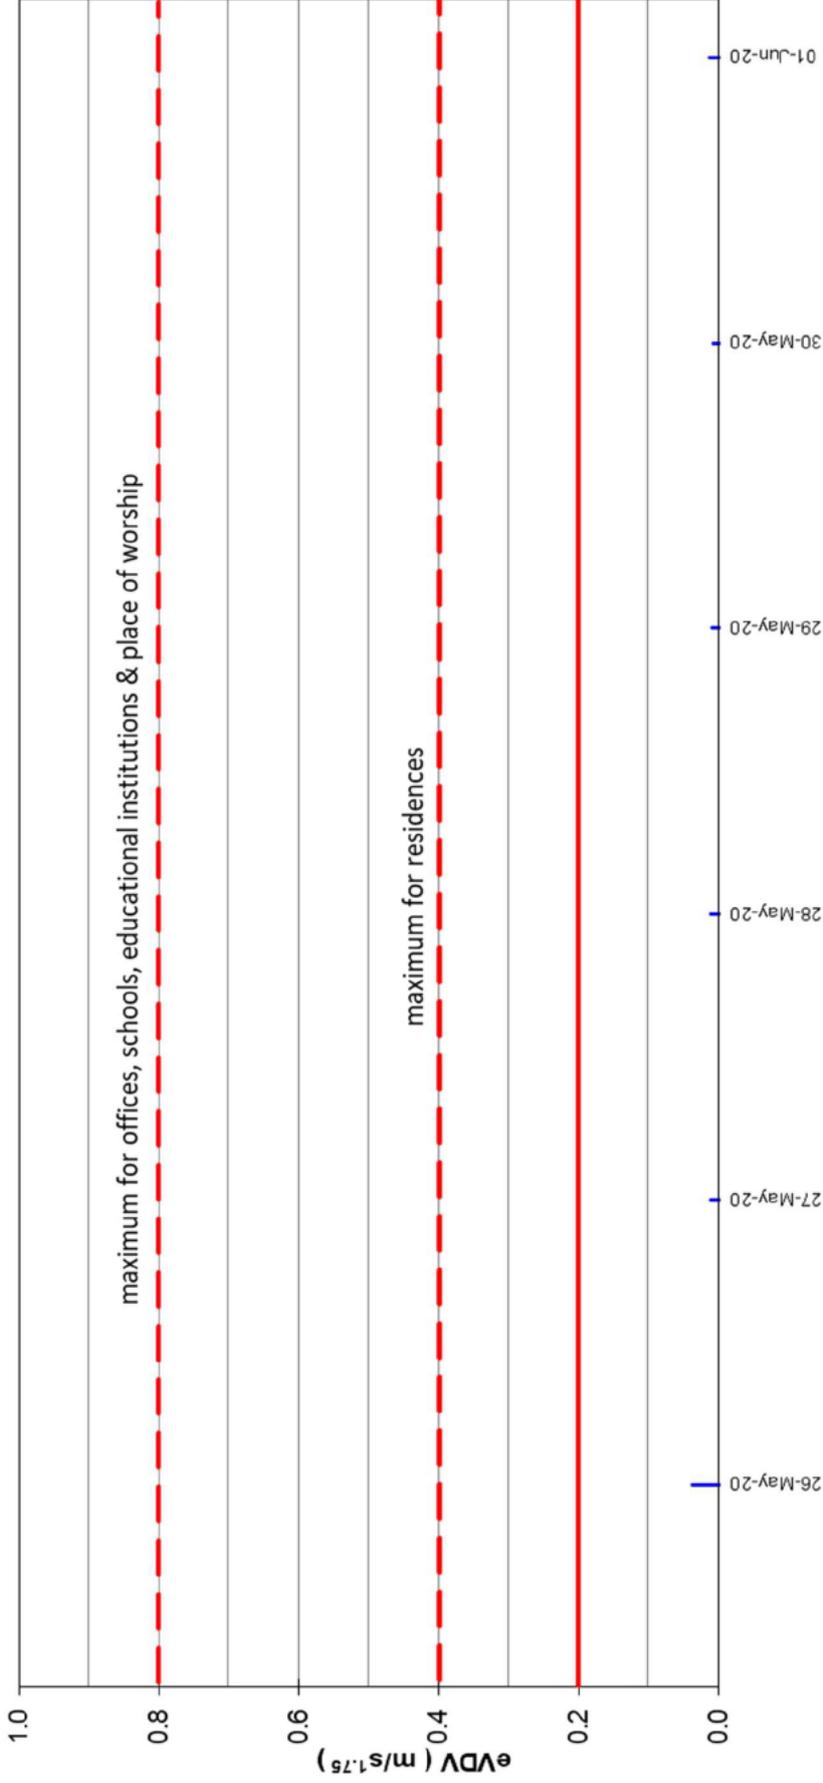
Vibration Dose Values - Goulburn Base Hospital Redevelopment
(Monitoring Location B - NE-cnr of pathology-mortuary building)

— Estimated Vibration Dose Value (maximum component) — Allowed Vibration Dose (maximum for critical areas)

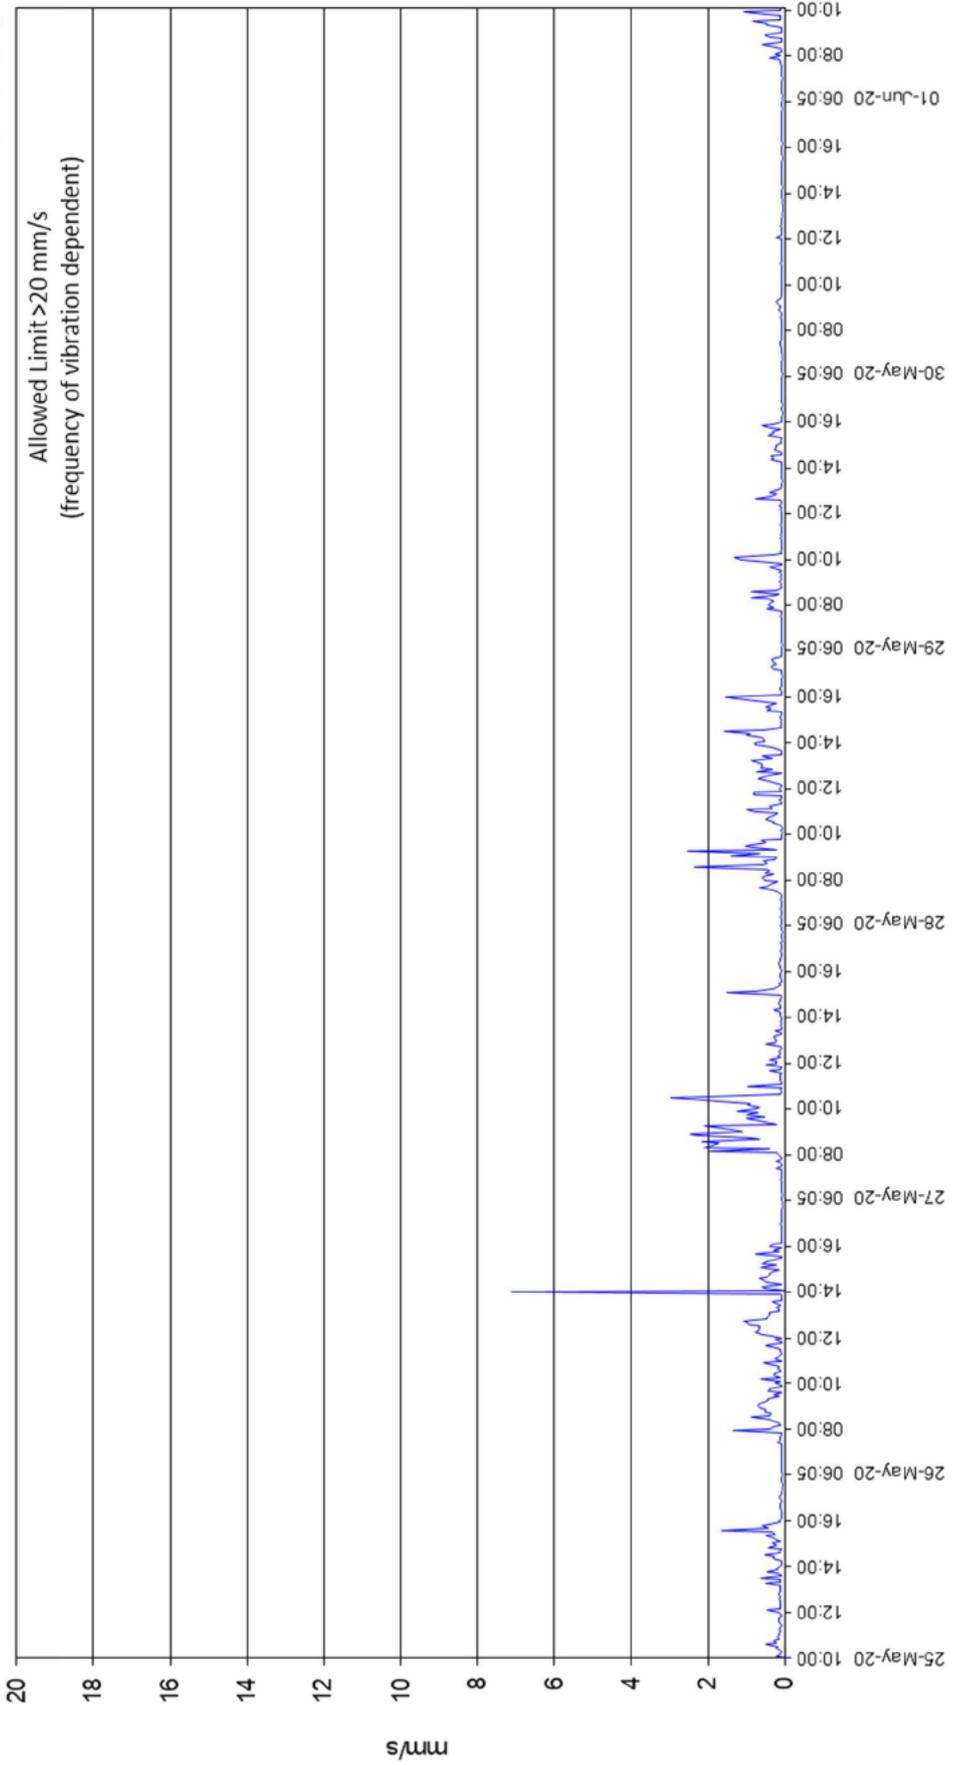
Vibration Levels - Goulburn Base Hospital Redevelopment
(Monitoring Location A - SE-cnr of pathology-mortuary building)

— Vector Sum Peak Particle Velocity (maxima within 5 min contiguous windows) & triggered events > 7 mm/s — Allowed Limit

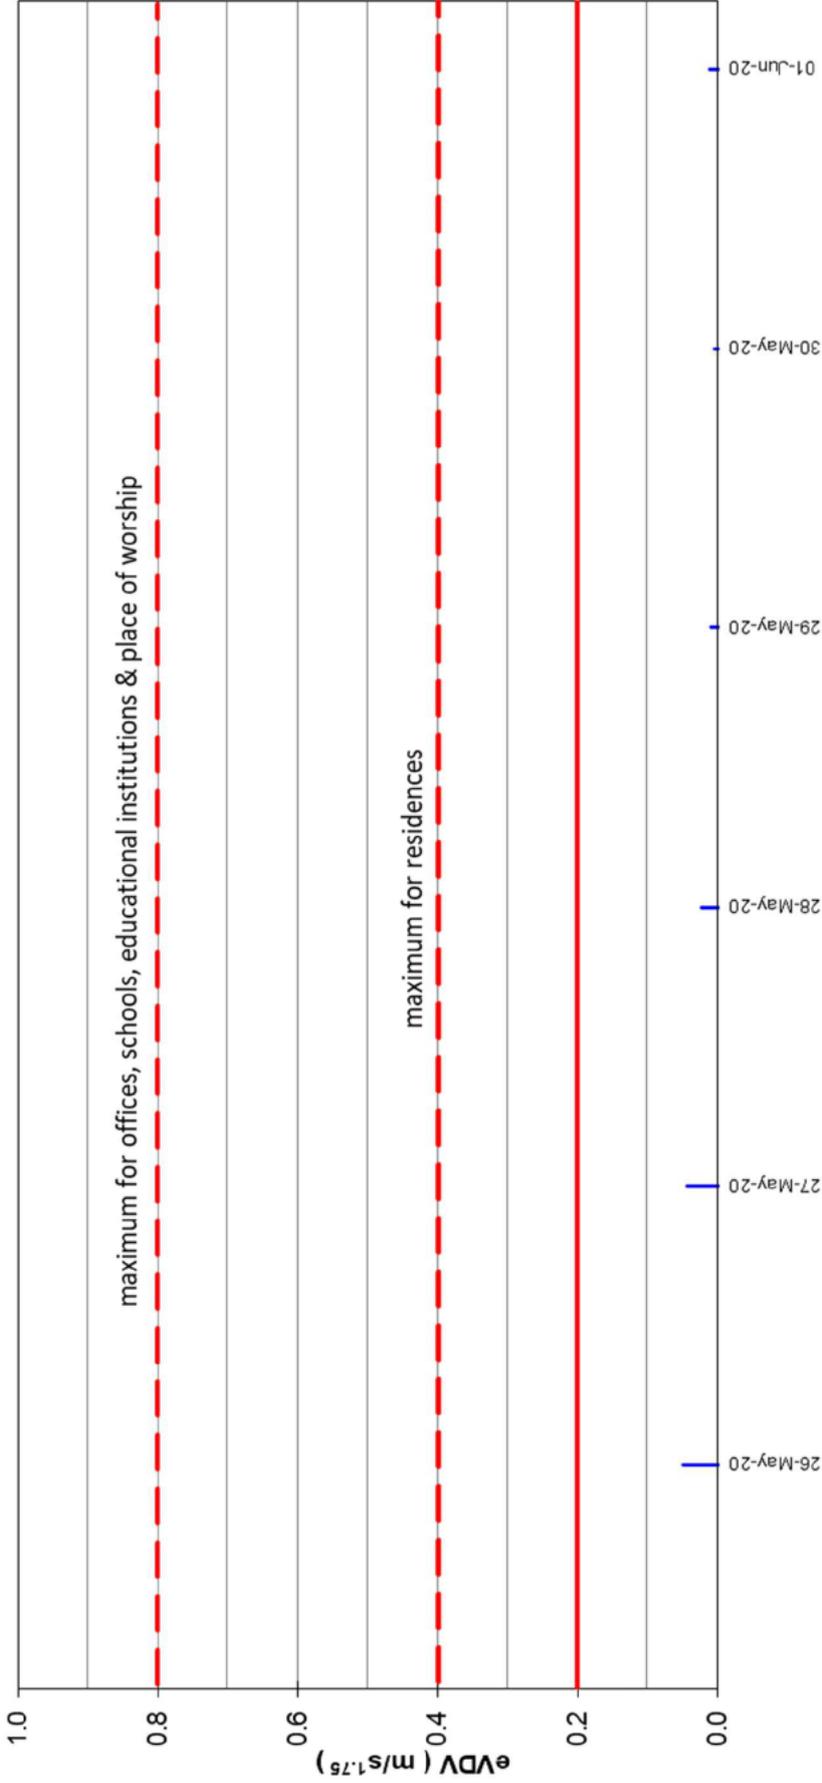
Vibration Dose Values - Goulburn Base Hospital Redevelopment
(Monitoring Location A - SE-cnr of pathology-mortuary building)

— Estimated Vibration Dose Value (maximum component) — Allowed Vibration Dose (maximum for critical areas)
