Attention: [REDACTED]
Report 685026-AFC
Project Name GOULBURN HOSPITAL
Project ID SYD191088.P003
Received Date Oct 29, 2019
Date Reported Oct 29, 2019

Project Name GOULBURN HOSPITAL
Project ID SYD191088.P003
Date Sampled Oct 28, 2019
Report 685026-AFC

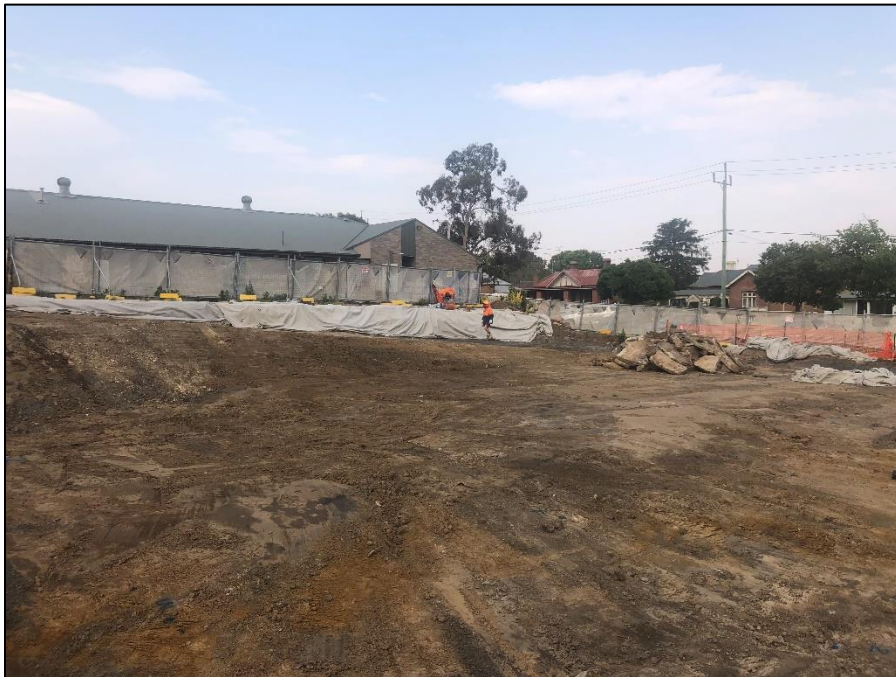
Photograph Prior to additional excavation on the northern extension located south of the Community Health Centre

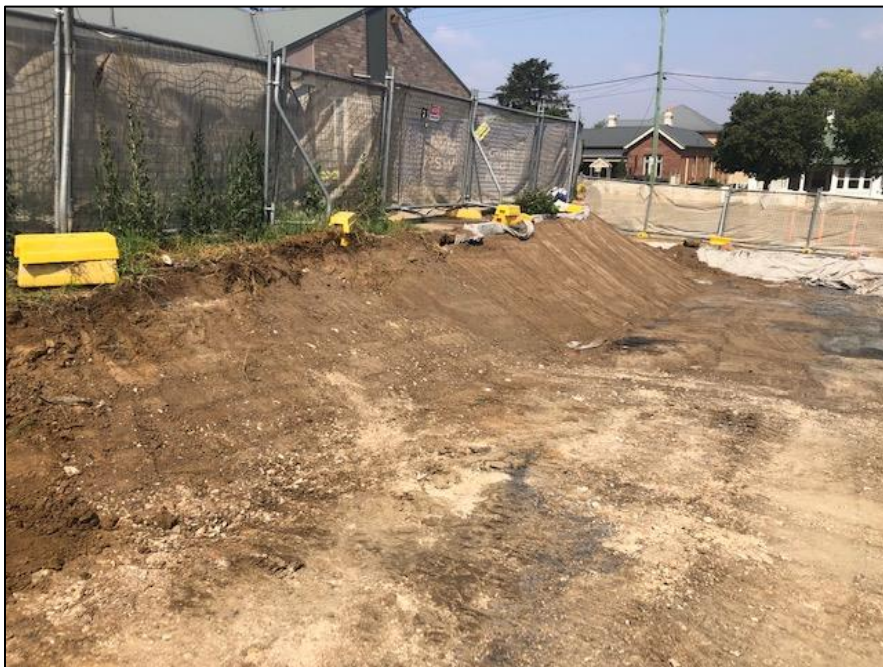
Photograph Post additional excavation and battering

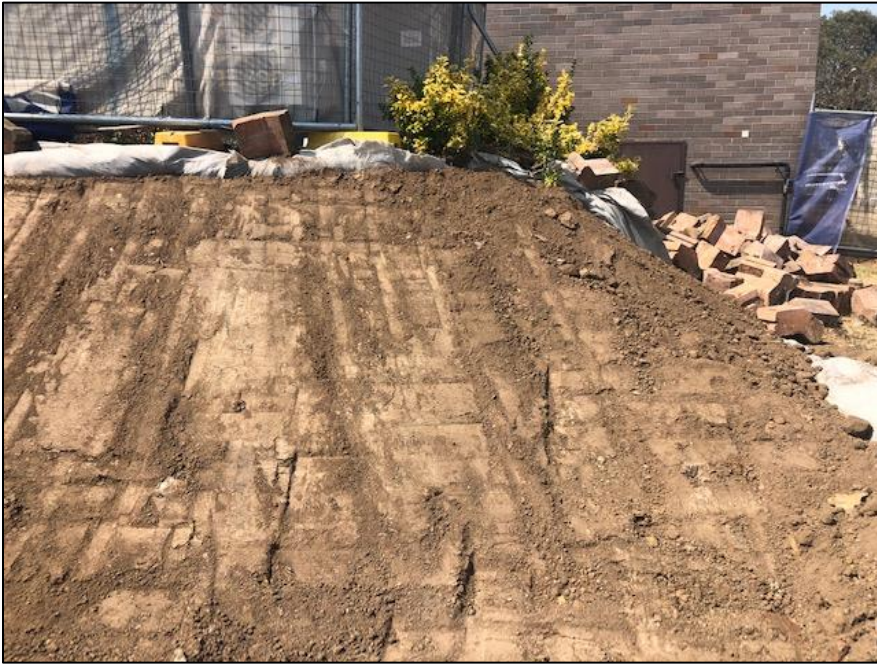
Photograph Post excavation and geotextile barrier evident on battered walls note varying depth of excavation to accommodate future site works

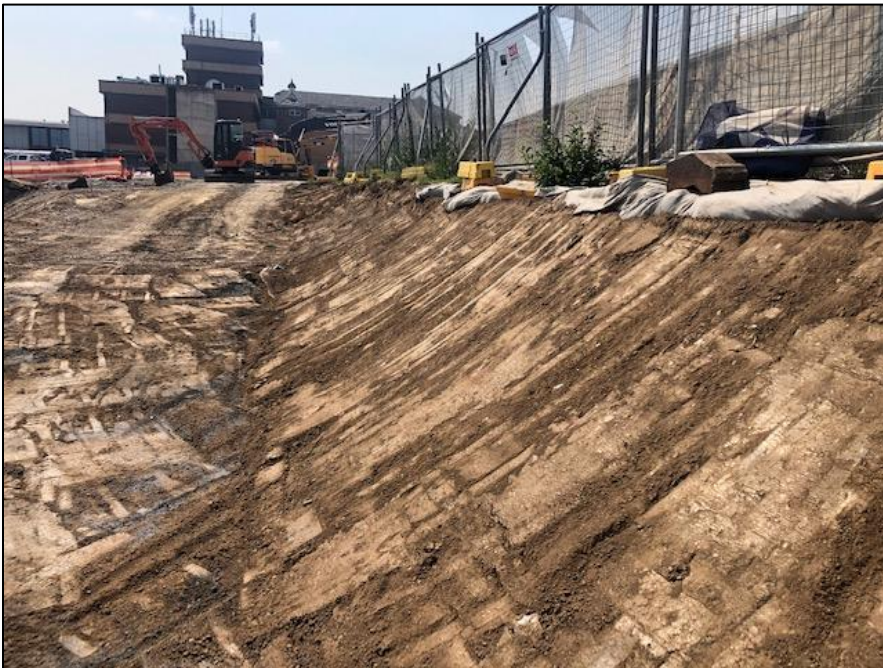
Photograph Post excavation and geotextile barrier evident and use of clean fill

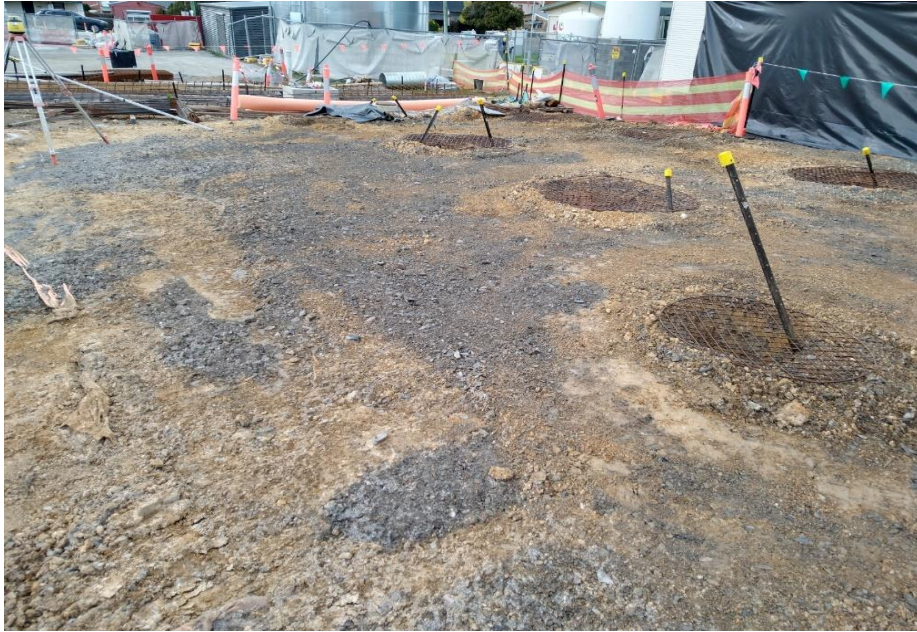
Photograph □□ Typical portion of Area Inspected following piling □ or □□

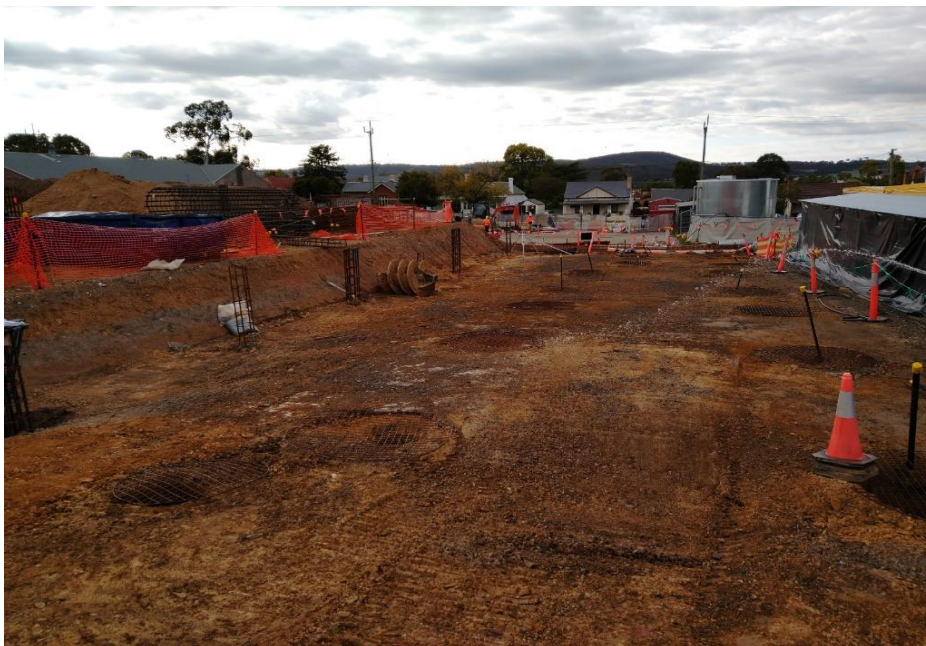
Photograph □□ Area Inspected as viewed from □ west to east following piling □ or □□

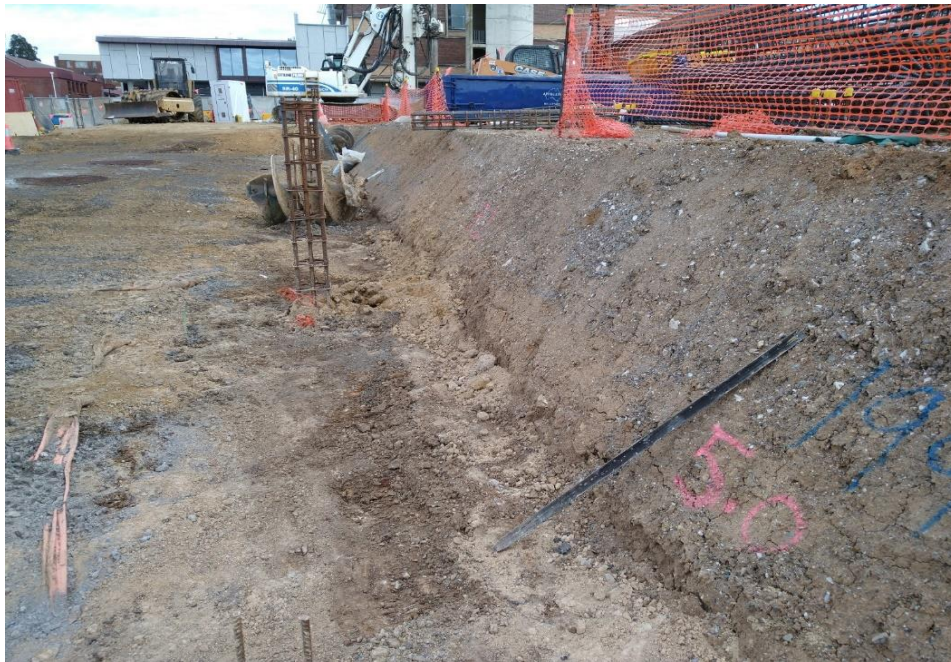
Photograph □□ Typical portion of Area Inspected (left hand side of photo) following piling
□ or □

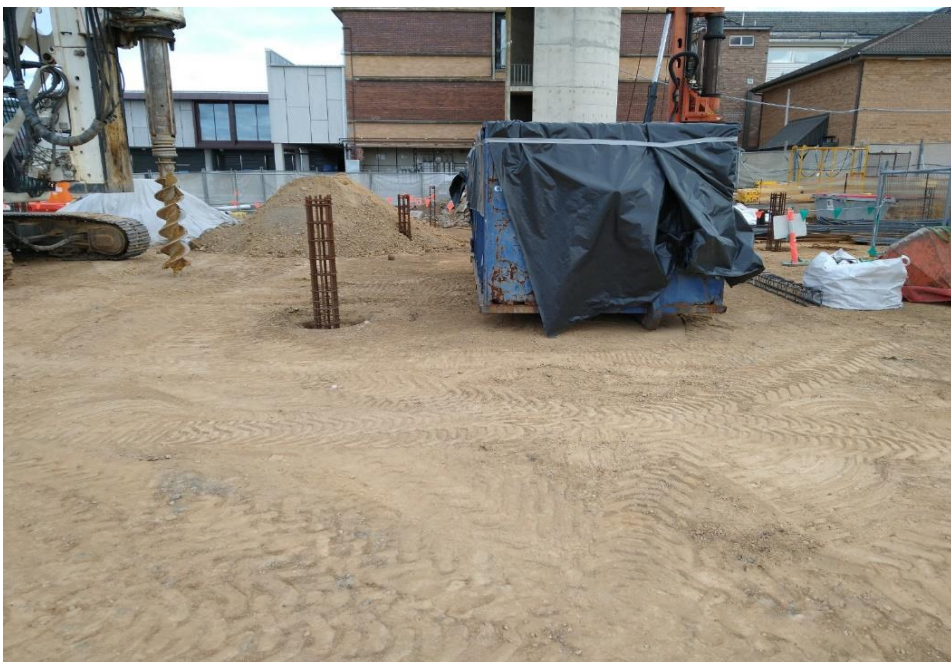
Photograph □□ Waste bin storage area □

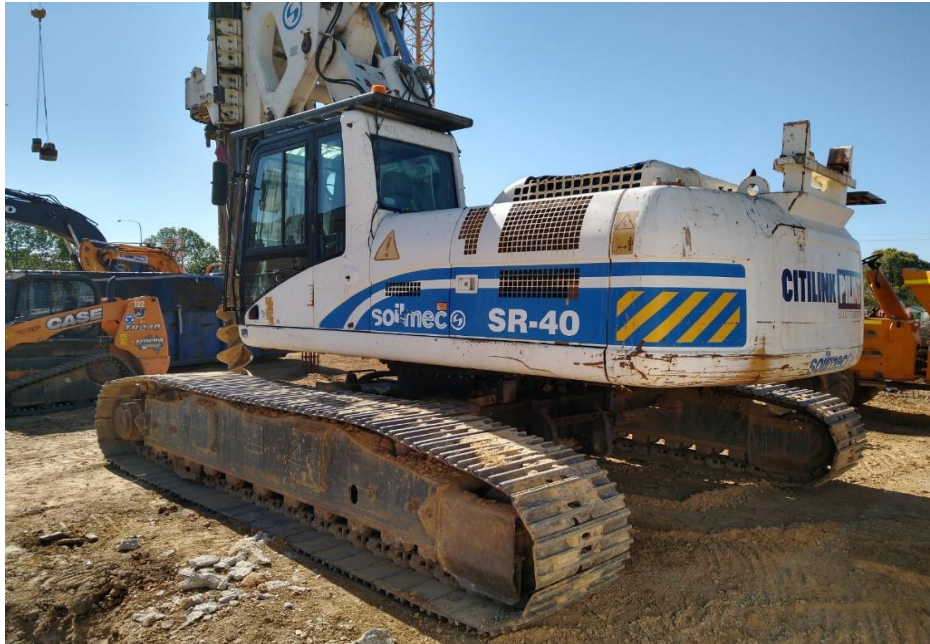
Photograph □□Piling rig□

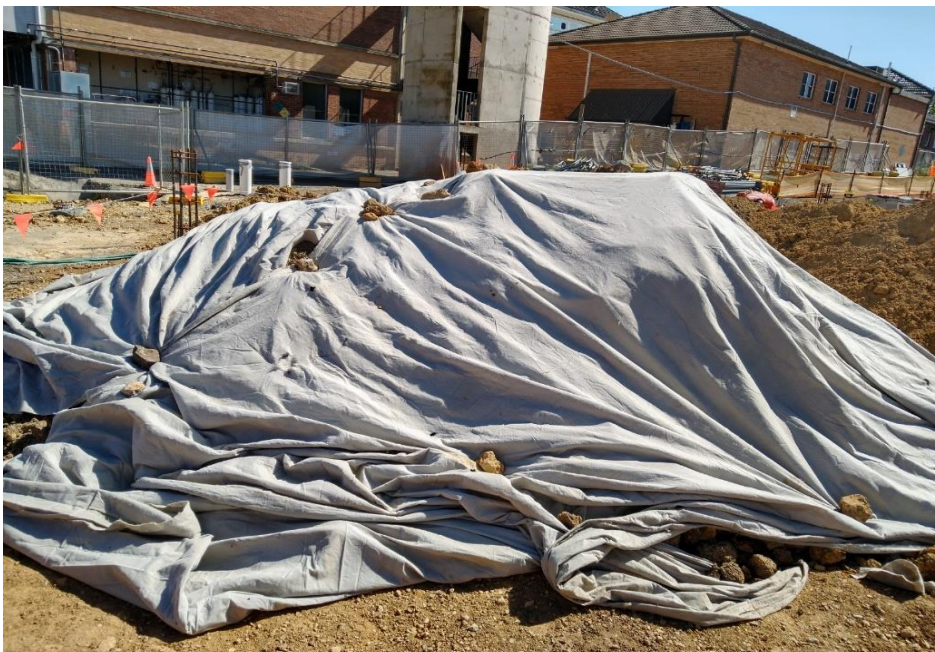
Photograph □□Asbestos waste stockpile excluded from clearance inspection□

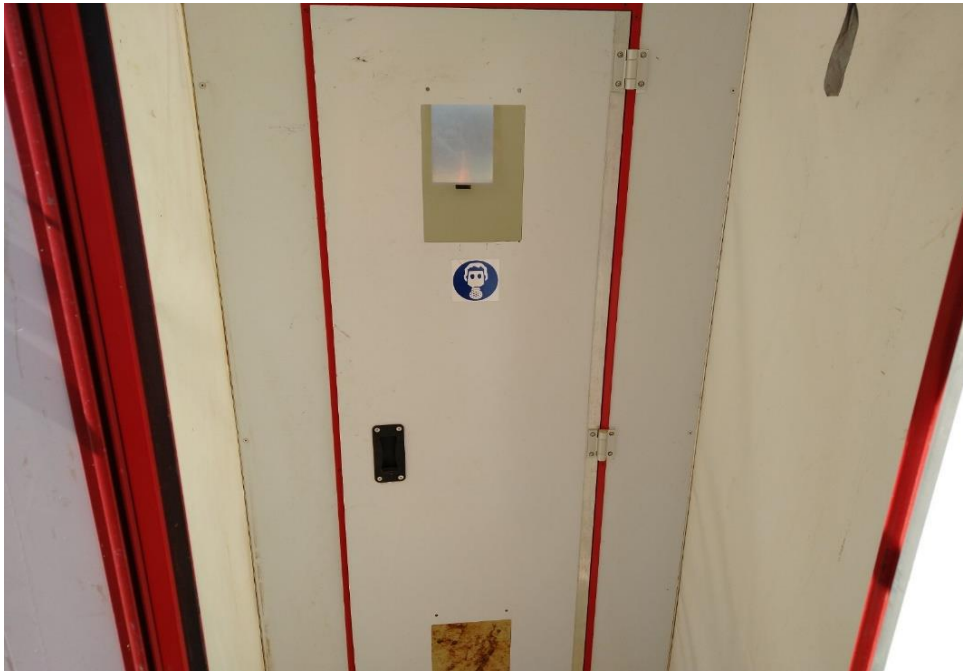
Photograph of Decontamination Unit

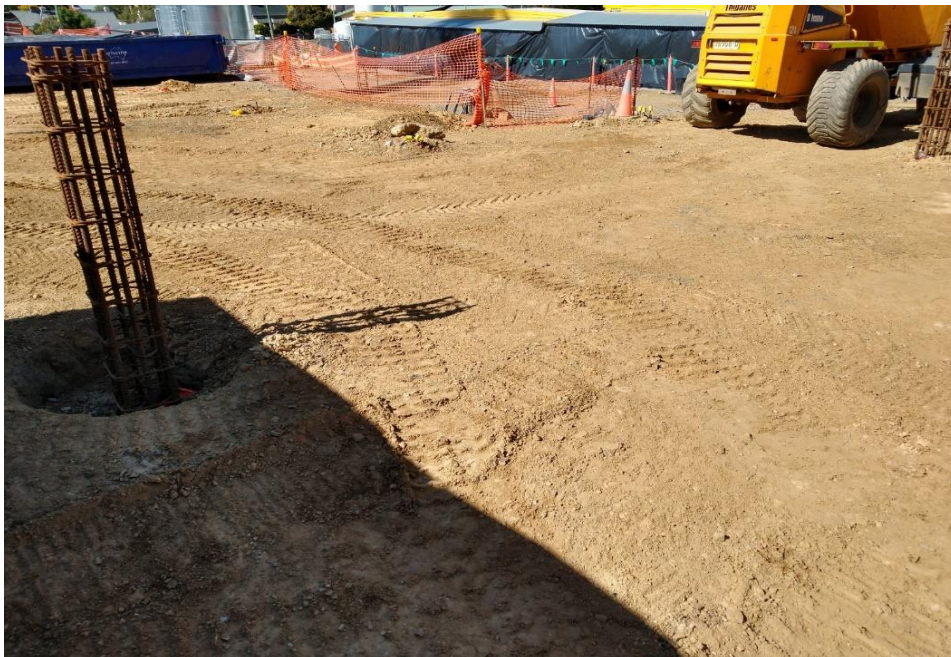
Photograph of Typical portion of bulk material transport route
